NORMALNI POPREČNI PROFILI R=1:50

line projekat / tehničke dokumentacije:
Tehničke dokumentacije poslovanje od ovog
odnosa puti i radi broj 18, deonika Beograd
10654-76, od puta pri izlazu broj 1,
deonika Beograd – Samostir od km 423/754,00 – km
564/107,34 i ulice Matije Gupca u Somboru

KOMLJA 1:
SVEŠKA 1:
DIO III: GRAFIČKI DIO
GRAFIČKI PRILOG BR. 3: NORMALNI POREZNI
PROFIL I DETALJI

Document Nr.	35/11	LIST:
Date	16.11.2011	
Score	1:50;1:20;1:10

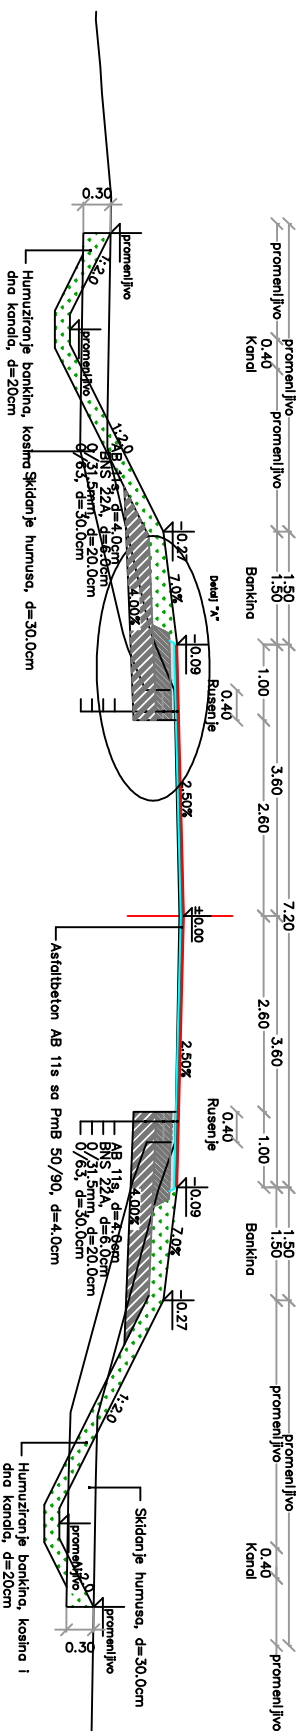
NPP 1 Deonica kroz Ul.Matije Gupca R=1:50
Homogeni potez od km 58+107.336 do km 59+759.887

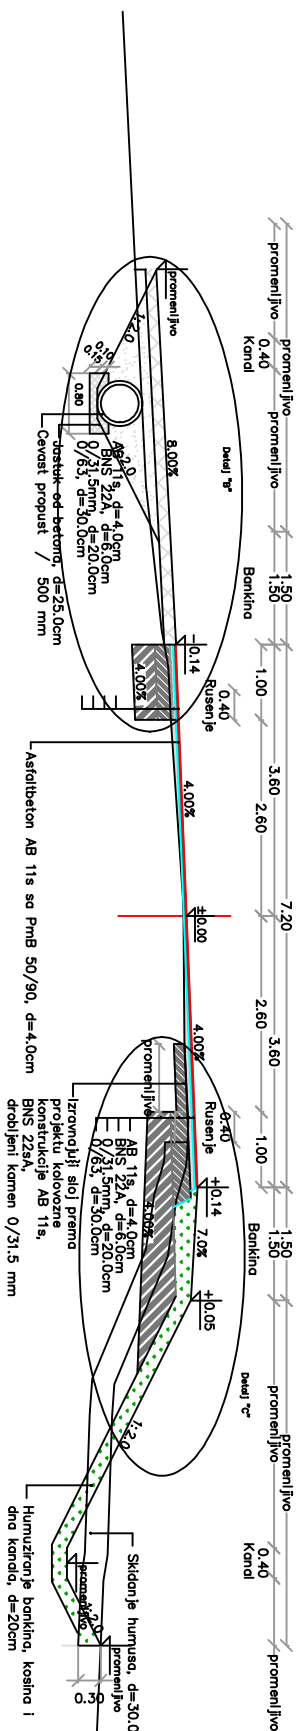
NPP 2 Deonica kroz Ul.Matije Gupca R=1:50
Homogeni potez od km 58+107.336 do km 59+759.887

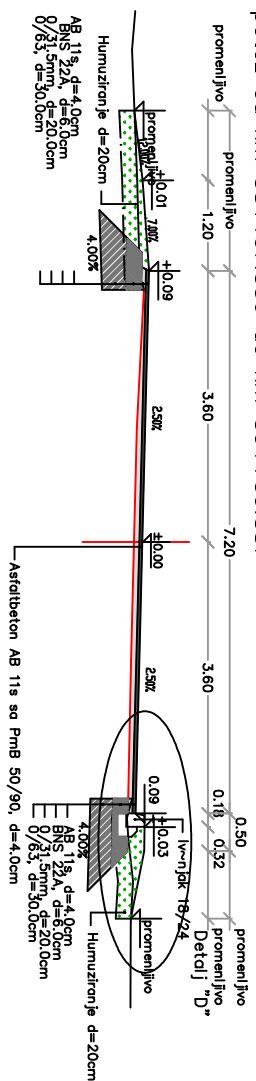
NPP 3 Deonica kroz Ul.Matije Gupca R=1:50
Homogeni potez od km 58+107.336 do km 59+759.887

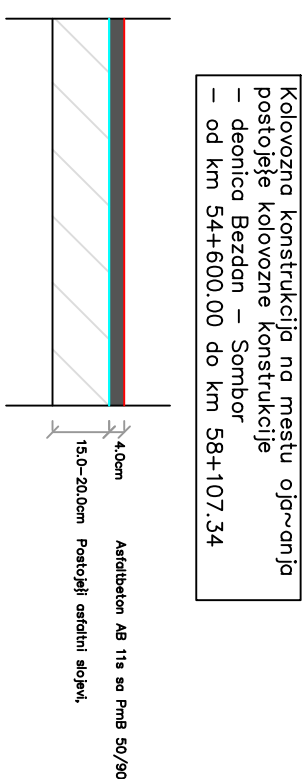
DETALJ KOLOVOZNE KONSTRUKCIJE R=1:10
